Quality Circle in Practice: A Case Study at Tecumseh Products Company

Dr. Ravi Shankar Kalva¹, V.Srinivasu²

²Sr. Manager Operations, Tecumseh Products Company, Balanagar Township, Hyderabad, TELANGANA, 500 037, INDIA

Abstract: This paper deals with the Quality Circle Case study carried out at Tecumseh Product Company Compressor Manufacturing division. The company has been sending Kit Assembly to their customer Tupelo. The customer assembles stator on Kit by tightening the 4 bolts with the help of Nut runner and some of the bolts were broken while assembling at customer end. The kit is rejected as a tapping defect and cost is debited to supplier plant. It was observed that the customer end PPM which was more than the target from AW Kit Assembly line. Victory Tecumseh quality circle working in this area took up this problem for study. A systematic application of quality control tools was used to find out the solution for the problem identified. The problem was analyzed and found the root causes as spring loaded tap adaptor travel incomplete depth and Chips getting trapped in stator holes due to Manual air jet cleaning of stator holes. Manual air cleaning of stator hole chips leadi

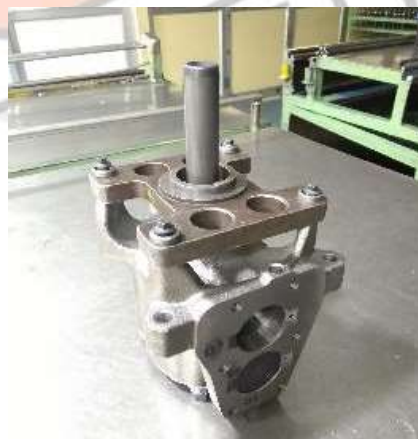
**Figure 1: Short Kit**

The company has been Sending Kit Assembly to our Customer Tupelo. They assemble stator on Kit by tighten the 4 blots with the help of Nut runner and observed that some of the blots broken while assembly. Then the Kit is rejected as tapping defect and Cost is debited to our plant. The Effects on External Customer are Increase Customer Line Rejection, Delay in Customer Orders and Increase Scrap Cost.

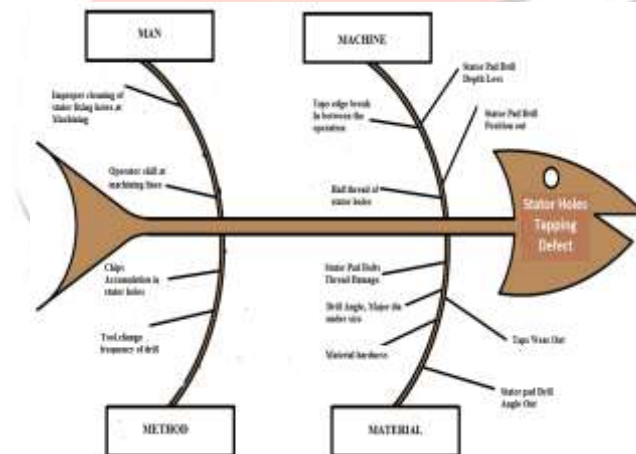
Figure 5: Ishikawa Diagram

Brain storming: the team after brainstorming has identified 13 causes as listed in Table 3.

1	Taps Wear out
2	Taps edge break In between the operation
3	Chips Accumulation in stator holes
4	Stator pad drill wear out
5	Stator bolts thread damages
6	Half thread of stator holes
7	Stator Pad Drill Depth Less
8	Stator Pad Hole Position out
9	Drill Angle, Major Dia under size
10	Improper cleaning of stator fixing holes at Machining
11	Material hardness
12	Tool change frequency of drill & Tap
13	Operator skill at machining lines

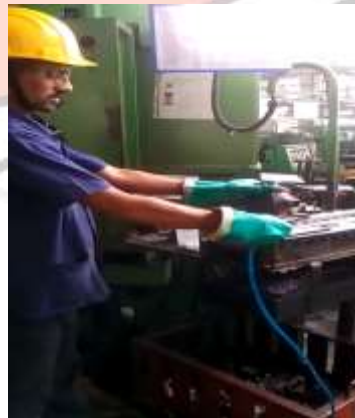
Figure 7: Before study Before Improvement

Root Cause: Manual air cleaning of stator hole chips leading to missing & solidification of chips.
