Tappet Noise Reduction in Motorcycle Engine

¹Nakul Bansod, ²Harinder Singh Negi
¹Assistant Professor, ²Sr. Manager, Manufacturing
¹Shri Vaishnav Institute of Technology & Science, Indore, India
²Mahindra 2-Wheelers Ltd. Pithampur, India

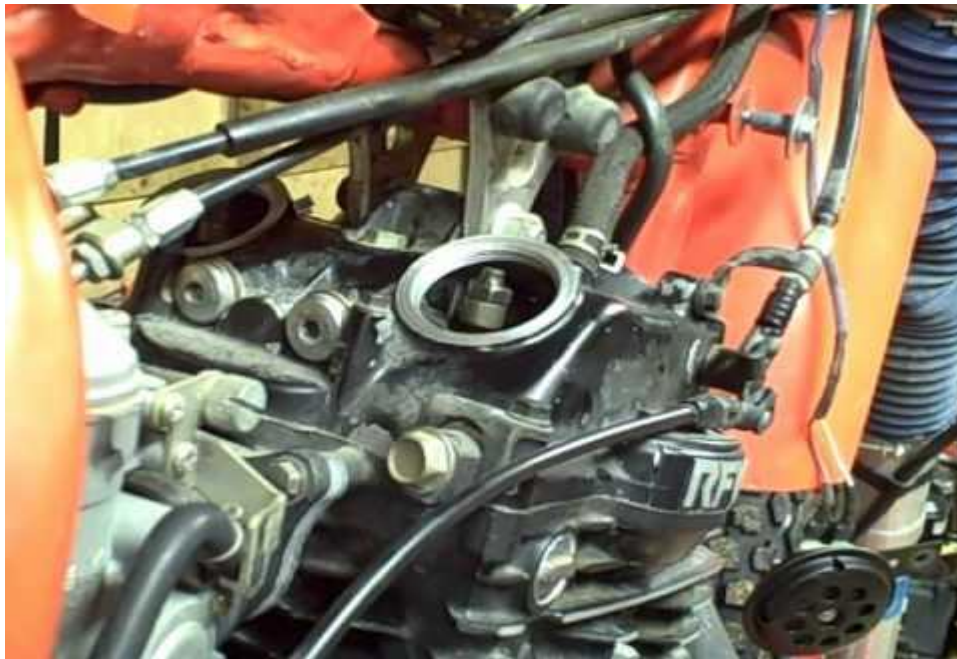
A tappet noise refers to the noise made by the Lash or Clearance between the **Rocker arm** and **Valve stem** in a car. It also occurs as a result of the lash or clearance between the **valve lifter** and **valve stem** at start up for at least 30 seconds. It normally occurs if oil is not regularly changed.

Figure 3.2. Tappets in Motorcycle

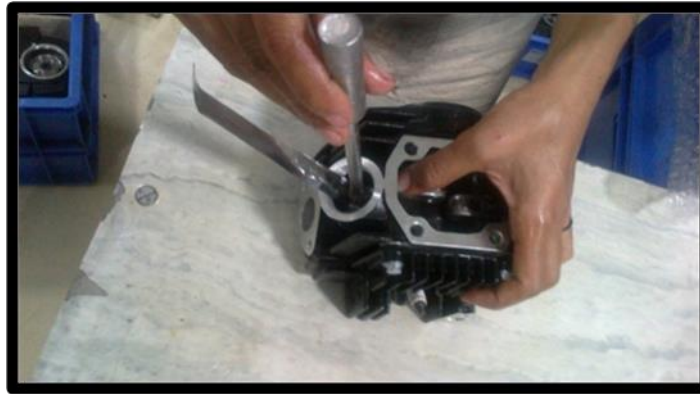
Figure 5.1 Tappet setting at sub assembly station

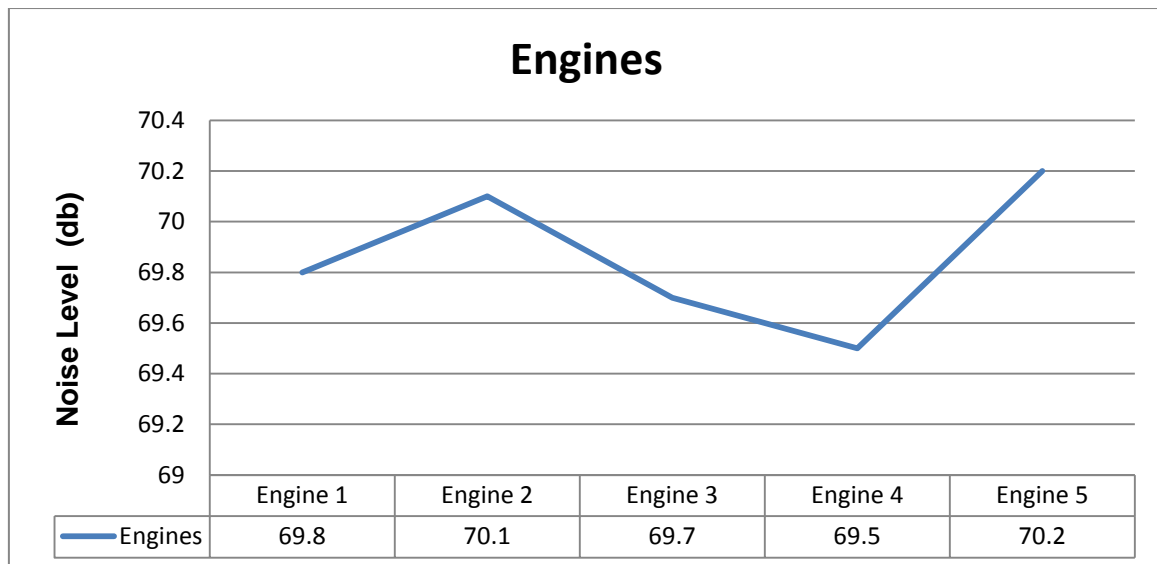
Here the decibel meter is kept at the distance of 1 foot from the noise source and the readings were taken. The data obtained is as follows:

Figure 6.3 Noise level data of normal engines

Hence the average noise level of normal engines is 70 db

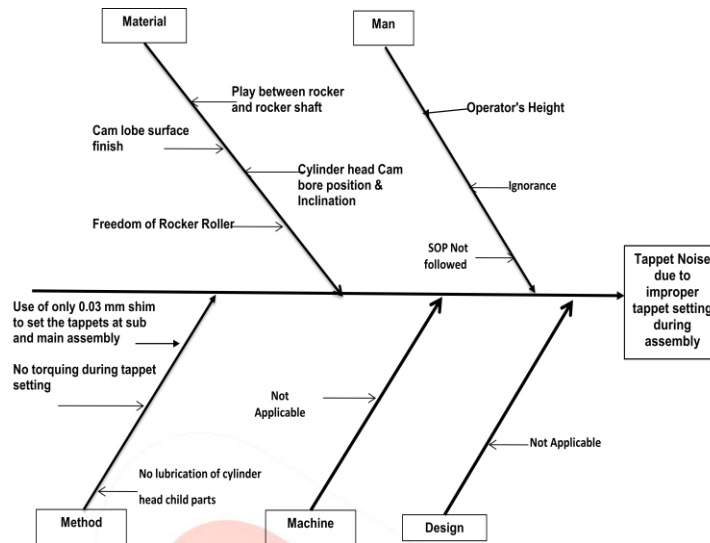
The level 1 analysis is represented by a fish bone diagram, the fishbone diagram looks like the skeleton of fish and hence the name is fishbone diagram. The fishbone diagram consists of 5 factors which contribute to the problem. These 5 factors are:

Figure 7.1 Fish bone diagram

From the above diagram, it can be concluded that the contributing factors to the tappet noise problem can be as follows:

- 1) **Man**
 - SOP not followed
 - Operator’s height
 - Ignorance
- 2) **Material**
 - Play between rocker and rocker shaft
 - Cam lobe surface finish
 - Cylinder head cam bore position and inclination
 - Freedom of rocker roller
- 3) **Method**
 - Use of only 0.03 mm shim to set the tappets at sub assembly and main assembly
 - No lubrication of cylinder head child parts
 - No torquing during the tappet setting
- 4) **Machine**
 - Not Applicable
- 5) **Design**
 - Not applicable.

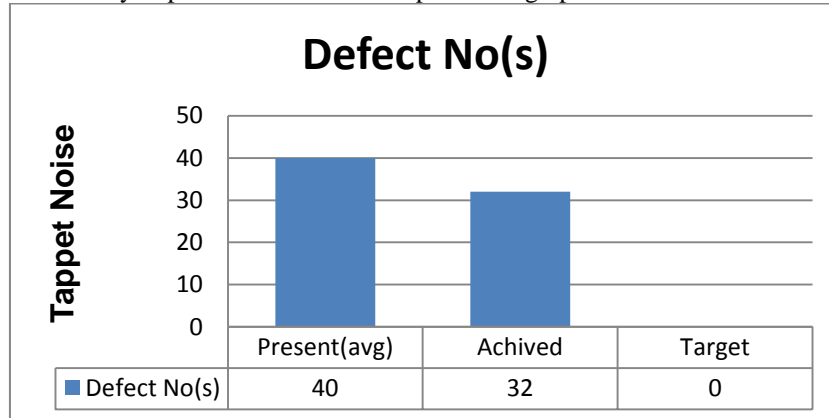
After the implementation of this counter measure, no number of cases reduced to 32 (average) from 40 initial (average). Thus the first countermeasure was successfully implemented. The results plotted in graphical form are as follows:

Figure 8.2 Result Conformation

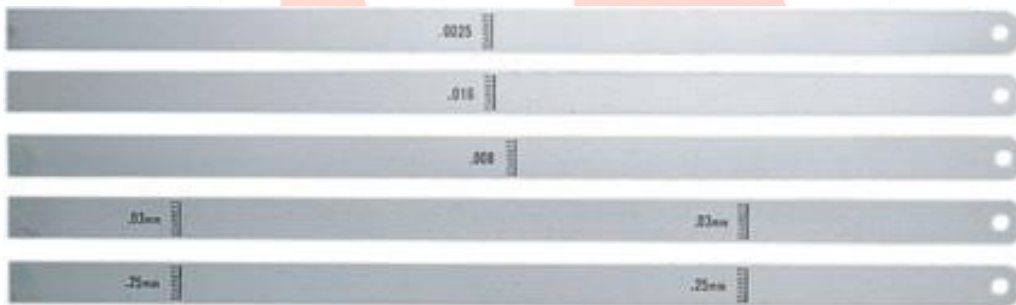
In this countermeasure, multiple shims (ranging from 20μ to 80 μ) were used during the tappet setting and data was recorded by performing the tappet setting of the various engines with shims of range of 20μ to 80μ.

Figure 8.4 Shims used in tappet setting

In the analysis part, the shims of 20μ to 80μ were taken and 10 engines were taken for each shim to perform the tappet setting. I.e. tappet setting was performed with each shim for 10 engines and the corresponding data were recorded.

It was seen that the number of cases reported was very less when tappet setting was performed with the shim of 80μ as compared to the other shims.

So the tappet setting started with the shim of 80μ and after setting the gap, it is rechecked with the shim of 30μ in case if the gap is more than 30μ. The rechecking is performed to ensure that there is no gap.

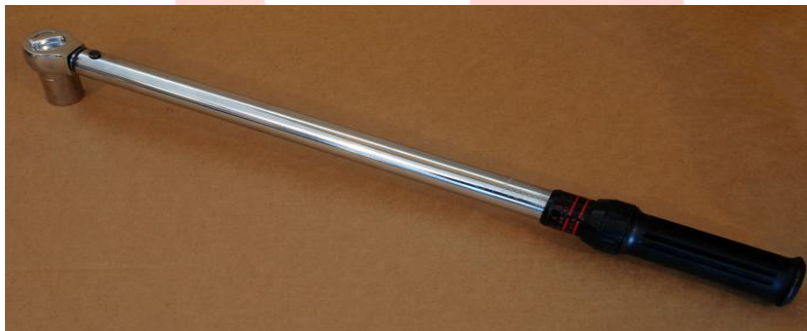
The torquing is done to ensure that the revolving components such as bolts, nuts etc is properly fixed in its mounting place. Torquing is done by the help of torque wrench which when applied to the screws, bolts etc gives a “tak” like sound which indicates that component is tightened properly.

It was observed that the torquing was performed during the tappet setting at the sub assembly but not at the main assembly station. The torquing of 70 kgfcm was performed at the sub assembly station. The absence of torquing at main assembly station was a key factor for tappet noise since due to rocker arm loose nut; there was play between rocker arm and valve stem of inlet and exhaust valves which was contributing to the tappet noise.

Figure 8.6 Torque Wrench

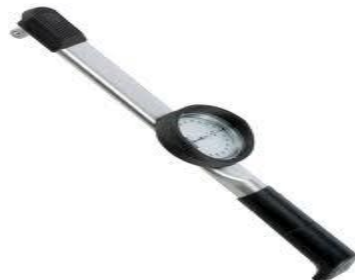
So following the analysis, the torquing of 70 kgfcm started on main assembly station. The torque for the tappet nut was found to be 70 kgfcm when measured by the torque wrench.

Figure 8.7 Dial Torque wrench
