# Experimental Study on T-Joint of Friction Stir Welding on AA 1065 Aluminum Alloy

**Abstract** - Friction stir welding (FSW) is a solid state joining process for joining high conductivity materials like aluminum and its alloys. In the present study T-joint at various parameters were produced by the friction stir welding. Some parameter provides defect free joints while the other parameters show defects. The tool pin is used in all the parameter is helical shaped. T-joints of AA 1065 aluminum alloy is made without defects. Experimentation will be carried out by changing principle parameters of FSW process. Macro and micro images of traverse section of the weld were captured and analyzed to identify the defects and the bead geometry values were found out using macro images. Most of the defects occur at advancing side at top side of the weld joint. The liquid penetrant inspection (LPI) test was performed for all the joints and no surface cracks were formed on weld line. Scanning electron microscopy (SEM) with Energy dispersive X-ray spectroscopy (EDS) spectra was taken at various weld zones, which shows the topography of welded zone and oxides formation. Tensile properties and micro

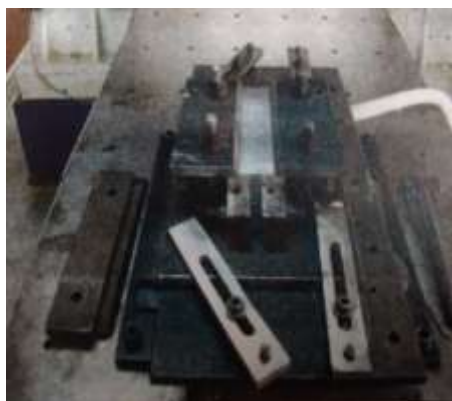
Fig.1. Experimental set up of process

FSW process experimental set up with two plates set at right angle and clamped with bed by using special fixture, as shown in Fig.1. The details about welding process, as shown in Fig.2. A cylindrical taper tool with tri-flutes, scrolled shoulder and with fins, as shown in Fig. 3, made of high speed steel (18% W, 4% Cr, 1% V) with pin length of 15.5mm was used. The tool was subjected to oil quenching and tempering to get 50 HRC. The pin and shoulder diameters of the tool are 14.5 mm and 40 mm

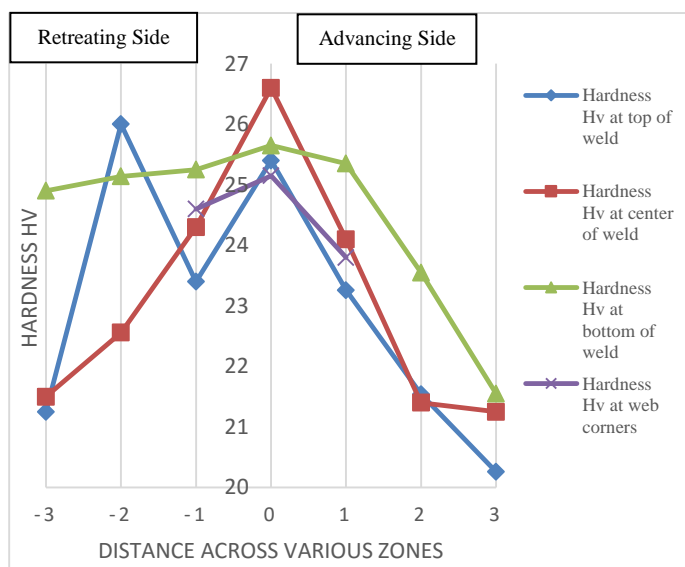
Fig.8. Micro hardness profile of Joint 2A

It is noted that as tool rotation speed 320rpm and feed rate 25mm/min (Joint 2A) the hardness of the FSW samples is high as compared to lower parameters, as shown in Fig.8. In this case also the hardness values at bottom side of joints are higher than the top side of the joint. These parameters gave higher hardness web corners compared to center of the joint.

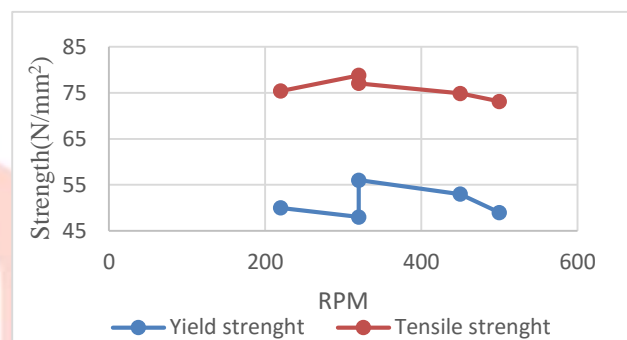
**Fig.10.** Schematic diagram of tensile tests

The tensile strength and yield strength variation is shown in Fig.10 and same with all the properties. At the lower process parameters were given slightly higher values than higher process parameters. Likewise % elongation has shown the similar results. L pull test also carried out, as shown in Fig.12. After testing the failure occurred at BM for all joints, as shown in Fig.13.

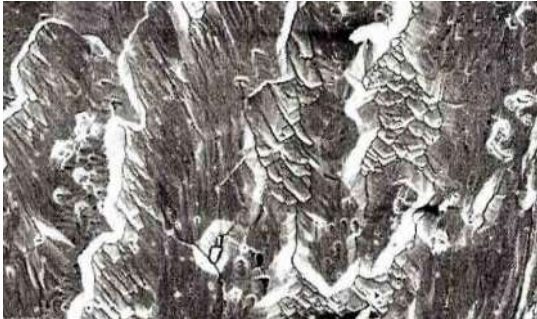
**Fig.16** Morphology at TMAZ of Joint 2A

EDS was utilized to identify the phases present in the TMAZ sliced specimens from aluminum alloy AA 1065. Two peaks, one large peak is aluminum and another one is silicon & oxides observed as shown in Fig. 17. Those only a few particles are located at the grain boundary while many others have been in matrix as shown in Fig. 16. From the EDS analysis it was found that the particles are likely  $Al_2O_3$  particles. It is well known that the amorphous oxide particles of AA 1065 aluminum alloy are easily substituted by the crystalline structure under long time thermal cycling. However, FSW is a welding process with relatively rapid heating and cooling resulting in no sufficient heat input for formation of the amorphous structures. Therefore, the amorphous oxide particles could not change into crystalline phases.
