# Failure analysis and stress monitoring of TVS Shaft located on satellite vehicle of Reel Transport Vehicle (Gantry) used in Newspaper Industry

**Abstract** - TVS (Transport Vehicle System) Shaft is the most important part which is responsible for the movement of satellite vehicle with accurate distance and positioning. Satellite itself has 1600 kg weight and paper reel has maximum of 2000 kg weight. Hence the TVS Shaft has to work with total 3600 kg load. Therefore the design and material chosen for the TVS Shaft is having maximum strength and sustainability under maximum load. But even using toughest material failure occurs usually in TVS Shaft. Which creates many problems in reel transportation system used in newspaper printing industry. Misalignment and faulty positioning are the major problems arising due to the failure of TVS Shaft. Hence it becomes essential to find the reasons behind failure and its remedies. Available literature focuses on design and toughest material used. But there is a more need to focus on stress concentration and loading capacity. In this paper failure analysis is discussed which is performed on FEA Tool ANSYS to find stress concentrating areas. Als

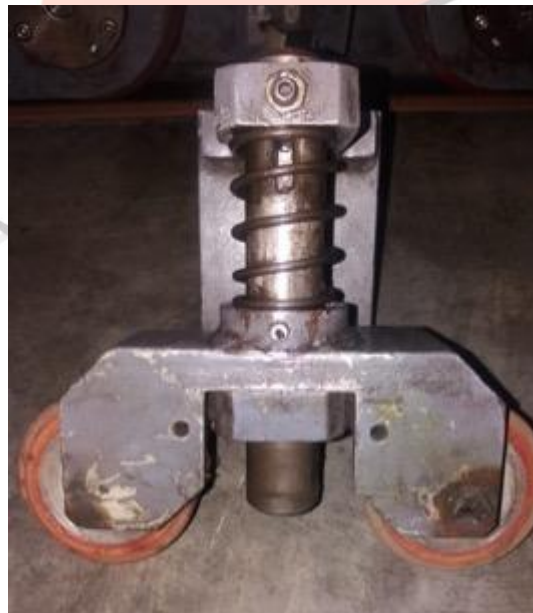
Fig. 1.1: TVS Shaft Assembly

TVS shaft is an important component in Transport Vehicle System. It mainly guides the satellite vehicle which is able to move in both X and Y direction. It also becomes a crucial member in guiding system as it is a part on which the wheels are located. Hence the failure of this shaft may create the problem in reel positioning and placing. Fig. 1.1 shows the TVS shaft assembly which has failed shaft from the bottom.

Helical spring is attached to absorb the shocks during travel. Wheels are attached for the proper movement in X direction. One more wheel is attached on the shaft itself for the movement in Y direction. This assembly is located on satellite vehicle of Reel Transport Vehicle.

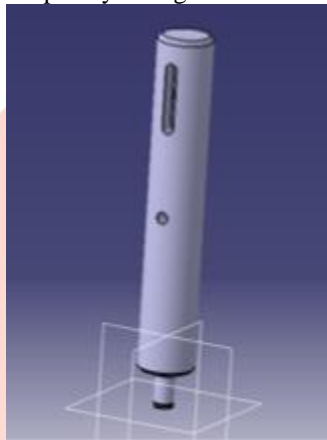
Fig. 3.1: CAD Model of TVS shaft developed in CATIA V5R19.

CAD modeling of TVS shaft is done on CATIA V5R19 software. Commands like revolve, pad, chamfer, fillet etc. are used to create the TVS shaft. All dimensions are taken from the reverse engineering process and detailed sheets available. Figure 3.1 shows the CAD model of TVS shaft which is developed by taking all the dimensions.
