Flood Mitigation of Goro Catchment in DireDawa

Abstract - Flood hazard has long history in Dire Dawa which is surrounded by the catchment of highland as well as low land. The city has been repeatedly devastated by flood disasters in the past. The main objective of the project is to estimate the peak Runoff and to assess flood mitigation measure. To achieve this objective, different prevention methods are used by using structural and non-structural approaches. Arc GIS 9.2 software is used to get soil type and land use, SCS curve number to get maximum run off, sieve analyses to know the grading characteristics of soil. It is concluded that the majority of soil particles are well graded, however there is also an indication of poorly graded soil. There is an effect of erosion and scouring. The monthly rainfall data analysis shows that, during the last 66 years from 1952 to 2017, the maximum values of monthly rainfall is calculated as 271.9 mm and the mean average value as 92.1mm. An increase in rainfall intensity, in association with other factors such as land-use change, increased population settlement along the river bank in the downstream area have contributed to raise the risk lev

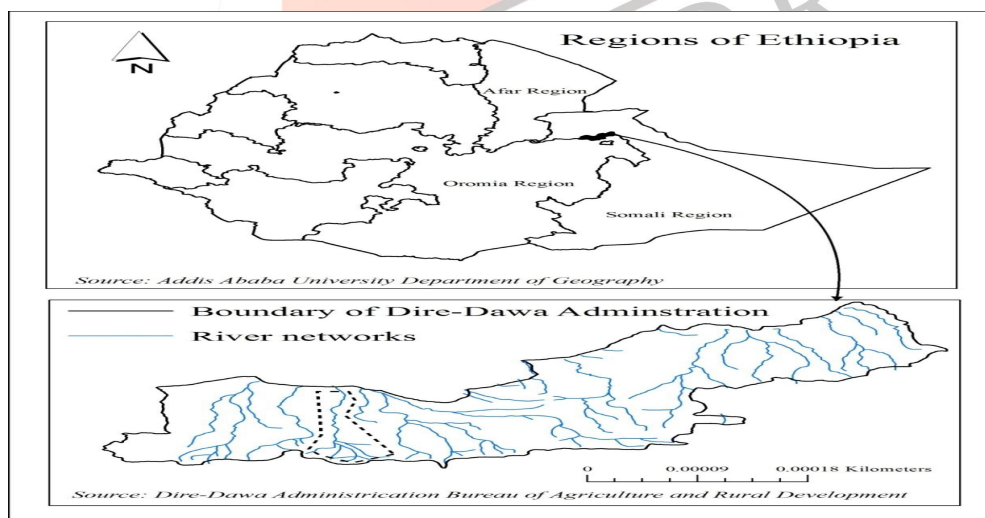
Fig 1: Location of Study Area

Note: Goro watershed is indicated within dotted polygon

This study was conducted in Dire Dawa city, Ethiopia which is located in the eastern part of Ethiopia. It is located between 9°28.1' to 9°49.1' North Latitude and 41°38.1' to 42°19.1' Longitudinal lines. Dire Dawa City is located in the Ethiopian rift valley with an altitude of 1000–1200 m above sea level and surrounded by mountainous districts of Oromia Regional States. The city is dissected by five large and small rivers Dechatu, Goro, Melka Jabdu, Laga Hare and Butuji rivers.

The Goro watershed is an elongated shaped with relatively wider areal coverage in the headwater region, but narrows downstream after the confluence, from which the main trunk of the stream starts. The river is sinuous and narrower in its middle reach.

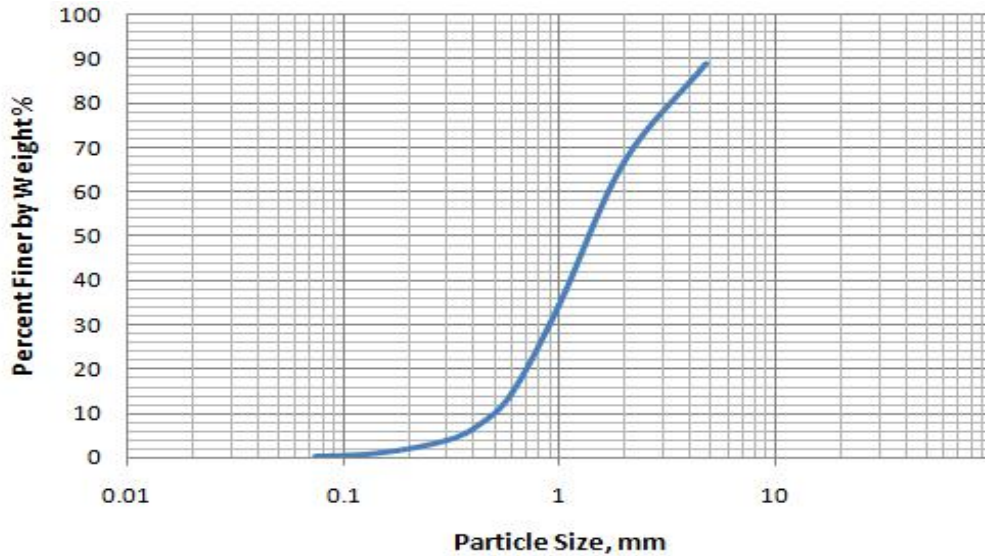
Figure5. Particle size Distribution curve

A number of samples were collected from various locations and Sieve Analysis was carried out in the laboratory. Based upon the coefficient of uniformity and coefficient of curvature result, it s found that the soil has uniformly graded soil which shows moderate erosion.

Based on the sieve analysis test it is concluded that the majority of soil particle are well graded, however there is also an indication of poorly graded soil.

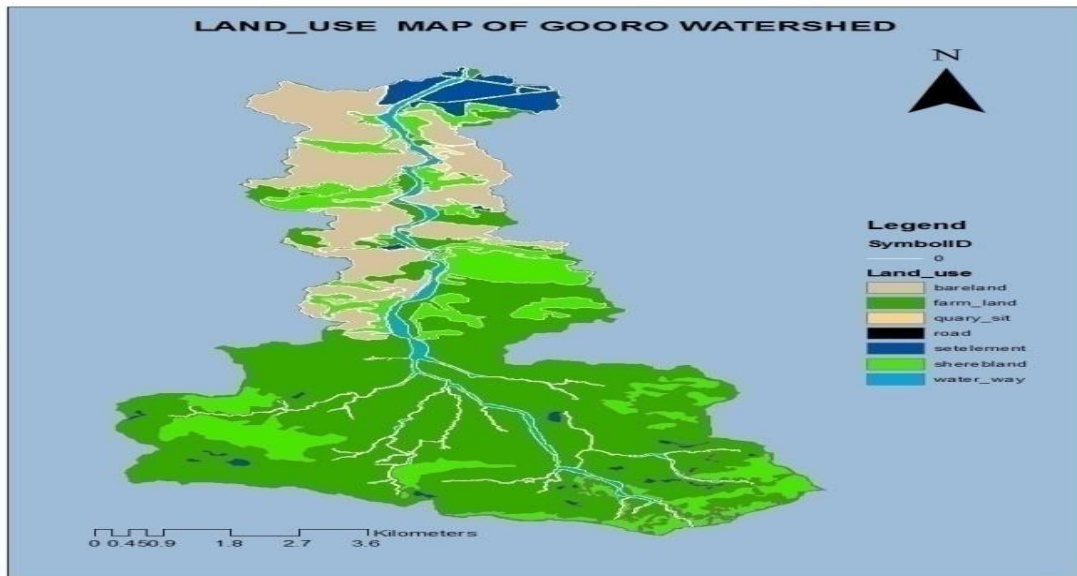
Figure 6 .Land use/cover map Goro catchment

In this study land use/cover map was developed using Arch-GIS and depicted in the figures 6.

According to Moussa et al., (2003) the main hydrological processes are affected by the spatial variability of soils, topography, land use/cover, climate, and human-induced changes and management. Land use/cover change as one of the most prominent component in the hydrological processes of a given area it is important to evaluate the changes that undergone in a given catchment so as to understand the hydrological behavior of the catchment. Accordingly, the major land use/cover changes that observed in Goro catchment was studied based on the thematic land use/cover map.

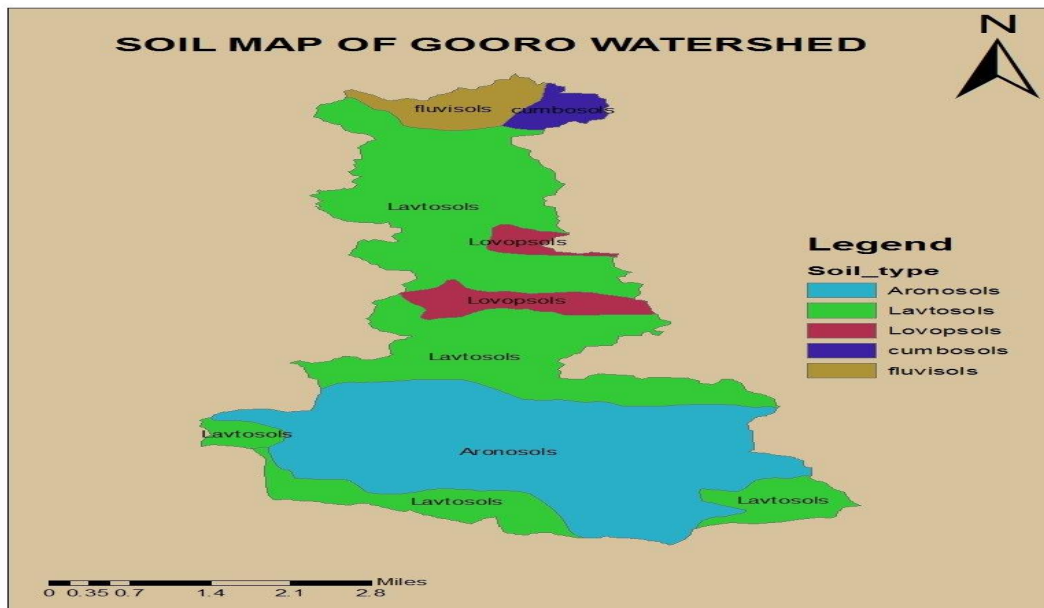
Figure7. Soil Data in the Required Range

Using GIS intersection of watershed map and soil, the following table is summarized.

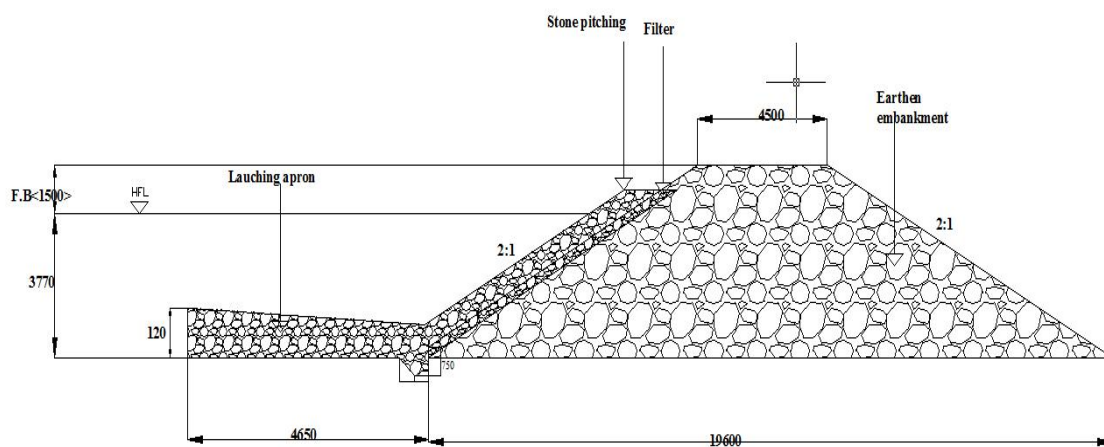
Figure 8.

- (i) Effective length of groyne, = 1/5x river width
= 98/5
= 19.6 m

- (ii) Spacing between groyne = 2.25 x effective length = 2.25x19.6
= 44 m

- (iii) Top width provided = 4.5m
- (iv) Free board provided = 1.5m
- (v) Side slope provided = 2:1
- (vi) Size of stone for pitching:-
Weight of stone,

$$(xi) \text{ Width of Launching apron} = 1.5 D_{max} \\ = 1.5 \times 3.1 \\ = 4.65 \text{ m}$$

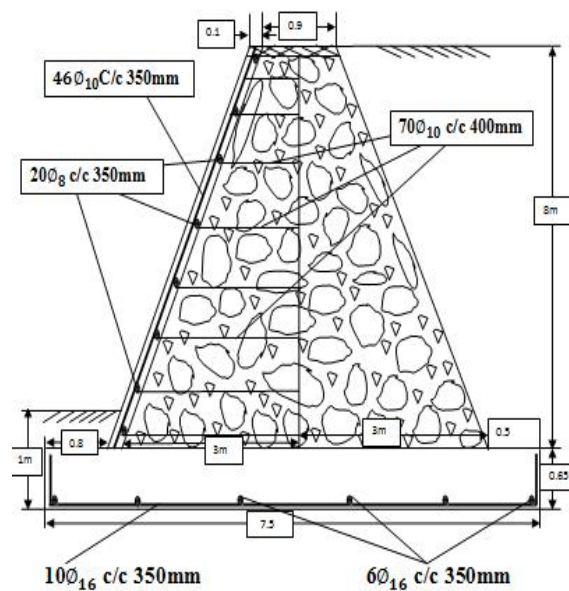
Figure9.

The proposed gravity retaining wall height is 8m. According to EBSC-7 the gravity retaining wall height should be less than or equal to 6m. So, there is a need to change gravity retaining wall to cantilever wall.

10Ø₁₆ c/c 350 mm is used for parallel to length of retaining wall.

6Ø₁₆ c/c 350 mm is used, for parallel to width of retaining wall.

46Ø₁₀ C/c 350mm at the face of retaining wall.

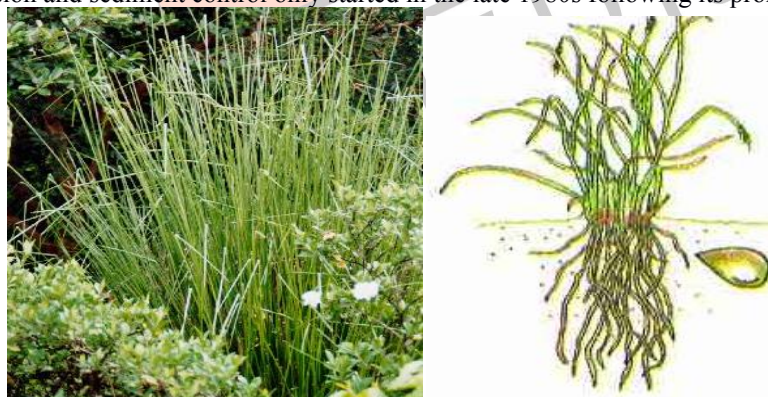
Figure 10.Vetiver grass

The Vetiver Grass Technology is simply the establishment of a narrow (less than 1 meter wide) live stiff grass barrier, in the form of a hedge, across the slope of the land. Vetiver grows quickly and forms a dense, permanent hedge which will slow down rainfall runoff, diverts and spreads it evenly, forming a very effective filter. It will trap runoff sediments to create natural terraces.

Vetiver is considered as a very deep-rooted penetrating grass variety which develops a fibrous profusely grown root system. The root penetration is mainly vertical and sometimes up to 3.6 m deep depending on the soil conditions. The strong fibrous root system binds the soil and can withstand the effects of tunneling and cracking. Also, its sharp leaves and aromatic roots repel rodents, snakes and similar pests.

Due to this reason, the use of vegetation as a bio-engineering tool for erosion control and slope stabilization is of utmost important. In our context, specially, Vetiver grass is very effective to control the effect of degradation effect due to its unique characteristics.
