Supply of salvaged shafts as new ones: failure cases to study malpractices and their effects

¹Manager – FA&PMIG, ²Chief – Scientific Services

¹Failure Analysis and Plant Metallurgical Inspection,

¹TATA Steel, Jamshedpur, India

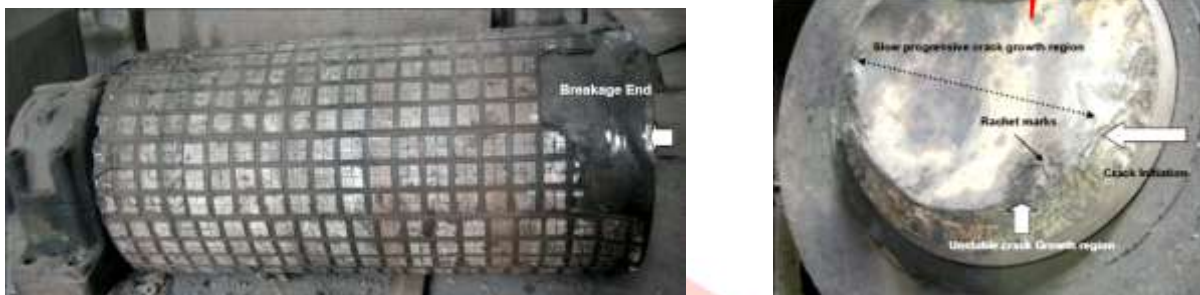
Fig. 1.1: Bend Pulley and its fracture Surface

These photographs show failed components and their fracture surfaces. Most common feature in all these failures that can be observed in fracture surfaces is presence of ratchet marks on the shafts periphery, smooth fracture surfaces (wherever visible) indicating fatigue mode of failure.

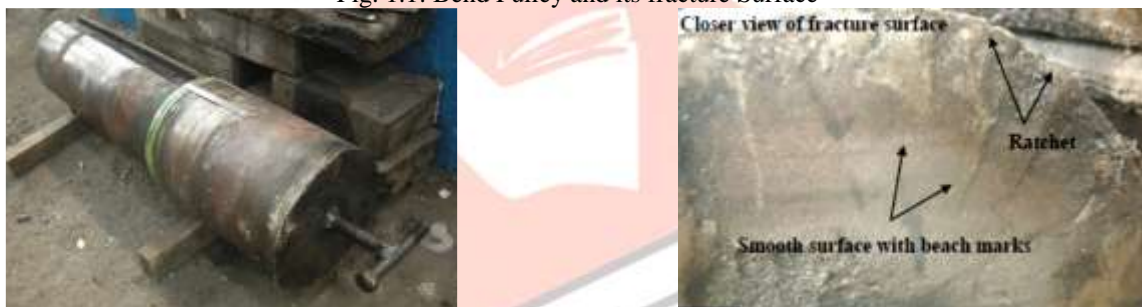
Fig. 1.2: Rotor shaft of impactor and its fracture Surface

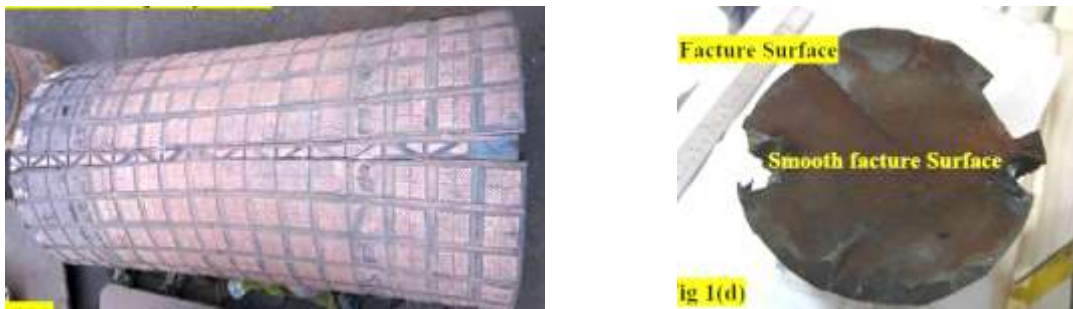
Fig.1.5: Pulley shaft and its fracture Surface

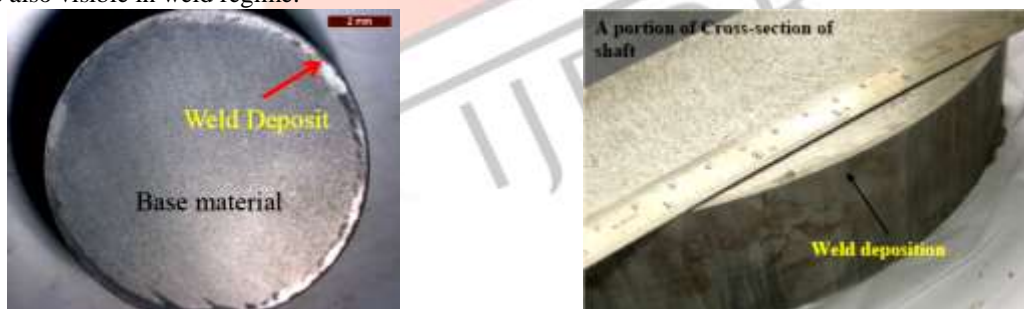
Of these six failures, representative macro and / or micro structures are shown in Fig 2.1 to 2.4. The shafts were cut in transverse direction, machined and the cross section was then macro-etched with 50% HCL solution in water. The cross section macrostructure shows distinct weld region across the periphery of the shafts. Transverse metallographic samples were cut for observing microstructure. The general views of such mounted micro-samples are shown in Fig 2.2. In unetched condition, micro-cracks were revealed in the apparently weld region in most of these cases.

Fig. 2.1: Macro-etched surfaces of (a) Armature Shaft (b) Rotor shaft of impactor.

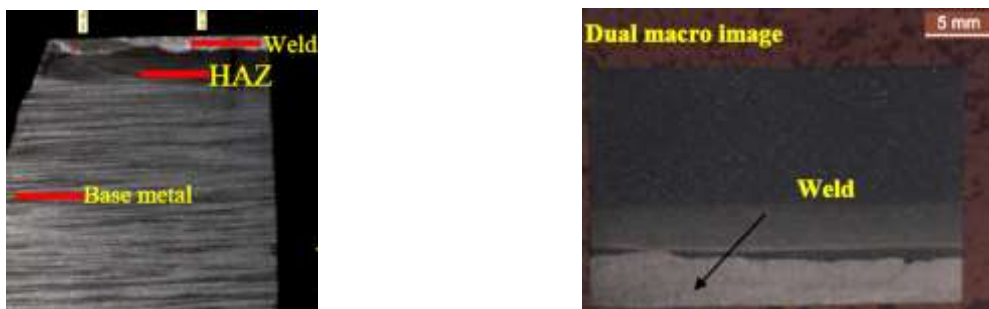
Fig. 2.2: Mounted micro samples of shafts showing distinct regions.

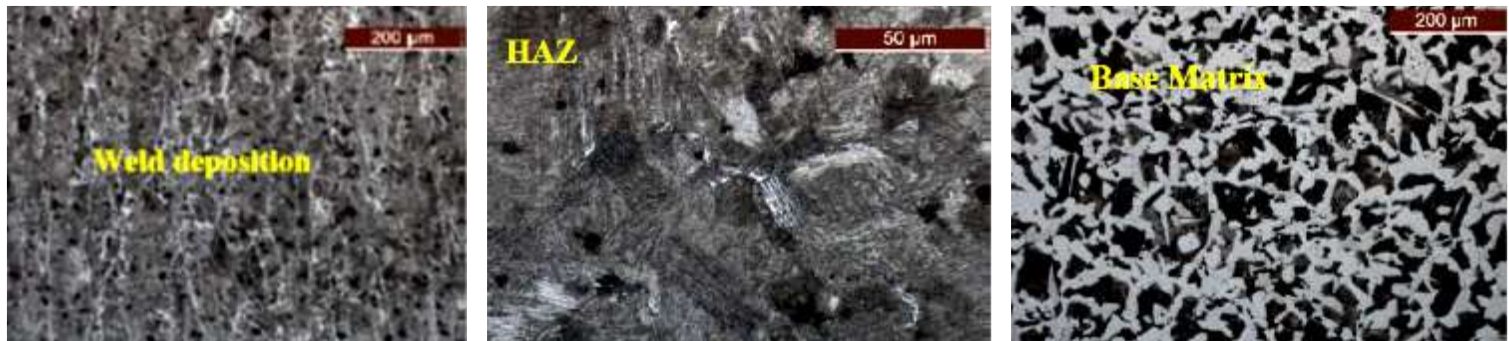
These samples were then etched with 3-5% Nital solution and observed under microscope. The etched microstructure in all these cases shows weld region at the surface (Fig. 2.3), heat affected zone (HAZ) and base metal. The base microstructure shows ferrite-pearlite microstructure for 45C8 and 55C8 materials. Base microstructure for 42CrMo4 and En24 shafts is tempered martensite and in some cases tempered martensite with bainite. HAZ in all cases is found to be majorly untempered martensite. Micro cracks are also visible in weld regime.

Fig. 2.4: Microstructures of one of the shaft showing transition from weld to HAZ to matrix
