# Microstructure and Roughness analysis of Drum brakes of Maruti 800

**Abstract-** The purpose of this paper focuses on the basic describing of drum brake systems in order to provide an in-depth microstructure analysis of the drum brake and also the roughness value of the drum surface as the roughness affects the braking capacity of linings on drum surface it also allows the duration of service of the drum This study will help because the study of wear will allow us to know the amount of wear on drum and to minimum roughness value of drum surface that is required to safe braking

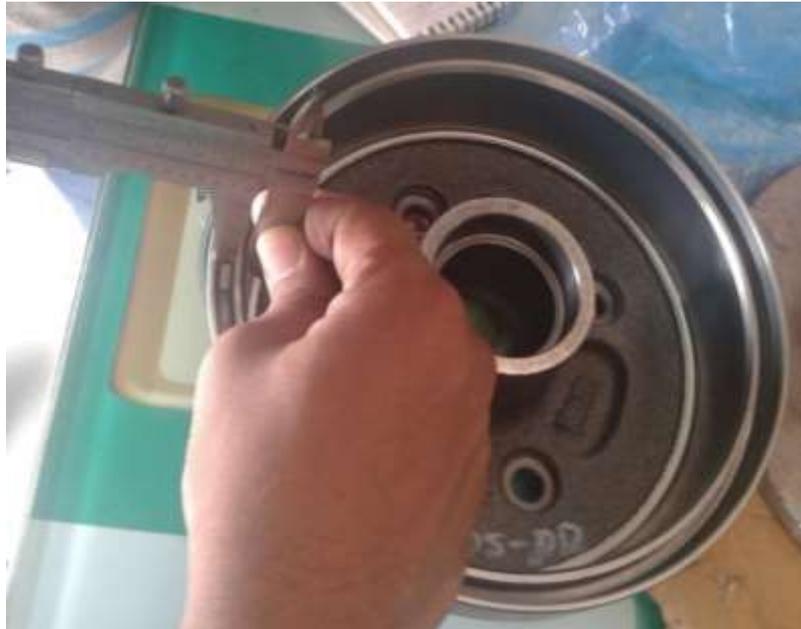
Figure 2.1 New Drum brake for Ra value

Standard dimensions of new drum brake are Diameter of drum: 180 mm

Sr. no	Ra value of new Drum	Ra value of Used Drum
1	1.2	1.9
2	3.5	2.0

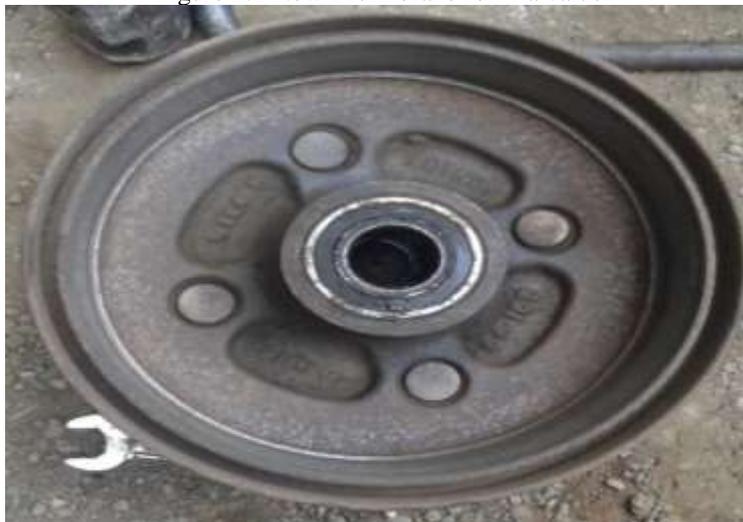
Figure 2.2 used drum for microstructure and Ra value

The selected vehicle has run 62900 kilometers and the wear is checked in the drum brakes in rear wheels as well as dimensions of used brake drum as found. As the brake drums are more costlier so they should be replaced very rarely so our focus is on brake drum rather than brake linings which are easier to replace

Thickness of brake lining is reduced by 1mm and on brake drum is reduced by 0.4 mm Wear on brake linings is seen and decrease in thickness of brake lining is seen There is two body abrasive wear on linng is seen as the liner materials is removed or cutted by the brake drum and straight lining is seen on liner and material is removed from liner so it is expected that to replace the liner after every 5000 kms

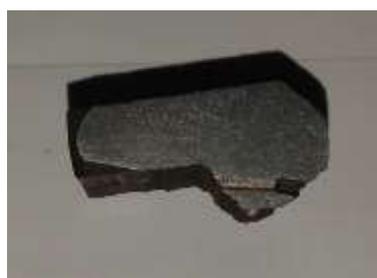
Figure 2.3 etched sample of 1x1” sample of drum brake

This sample was used to perform the microstructure analysis and to find out Ra value of the Drum brake

2.1 Micro Structure analysis of drum brake : The drum under investigation was removed and new drum was replaced on its behalf . And sample of 1×1” in was submitted to the metallurgical lab for microstructure analysis and roughness analysis Also another sample pieces of old and new brakes were submitted for Ra (roughness ) factor analysis. The above mention tests we carried out at ELCA LABS at thane The micro structure analysis was carried as per ASM H Book The longitudinal orientation with center location and 2% nital was used as etchant.

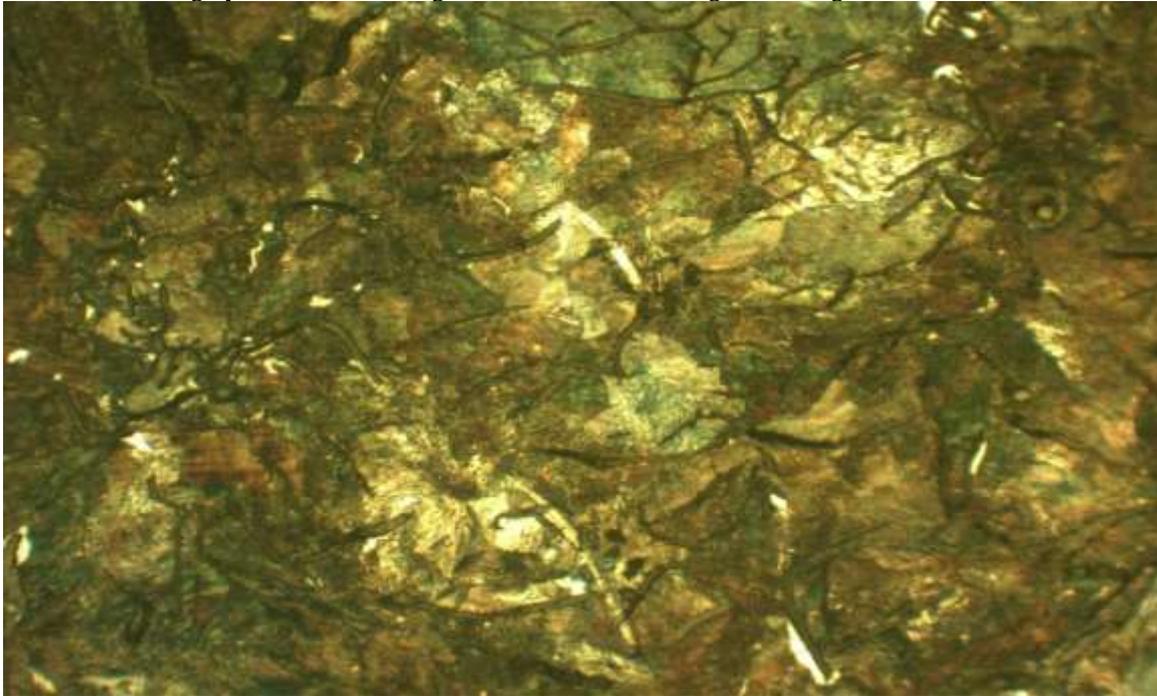
The microstructure analysis reveled that there was uniform distribution of Type A graphite Flakes in Pearlite matrix and the whole microstructue is grey cast iron The image below shows 200X magnified image of the drum brake

Fig 2.4 Microstructure of brake drum

The graphite flakes in the pealite matrix lead to unmachinable surface due to presence of graphite the brake may break during machining the microstructure does not change
